**foxpool**
Canada

CLEARGARD™

CORROSION RESISTANT
Steel Steps & Panels

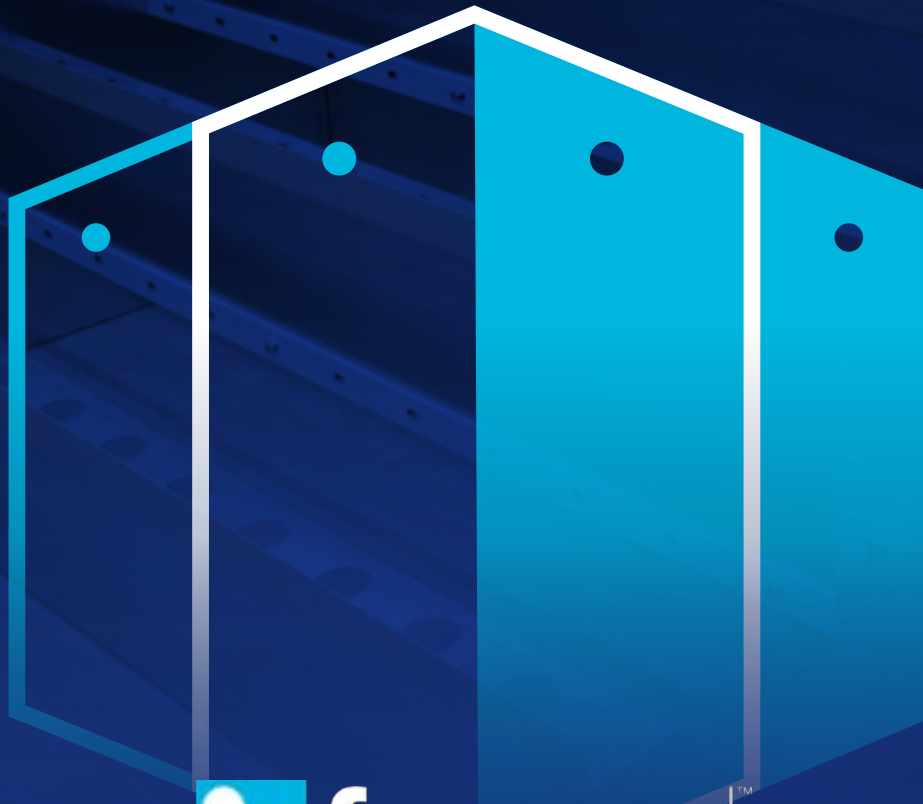
Fox Pool is proud to offer ClearGard™ – the most effective non-corrosive coating for steel walls and steps and panels in the industry. ClearGard™ is a hot-dip coated steel sheet that has a layer of Zinc, 6% Aluminum, and 2% Magnesium. The effects of magnesium and aluminum together allow our ClearGard™ coated steps to have excellent corrosion resistance, scratch resistance, and formability.

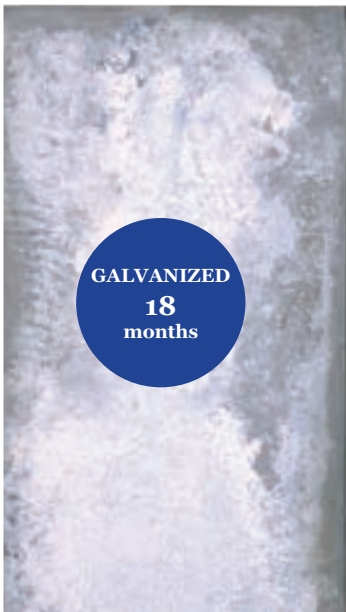
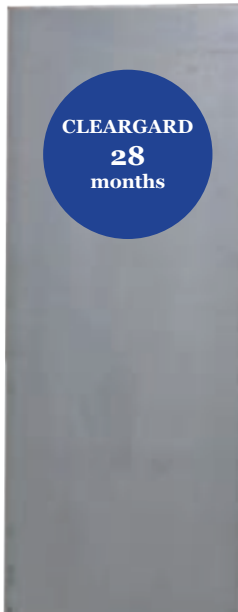
GALVANIZED
18 months

CLEARGARD
28 months

ClearGard™ offers superior protection against corrosion on Salt Generator Pools, **up to 5x's more effective than standard galvanization.** It also offers increased protection when servicing areas with a high water table or acidic ground conditions.
